Manhole Inspection Summary

Manhole # S23II_042MH

Insp Date: **10/1/07 9:16 AM**

Location Address: **617 CUMBERLAND ST**

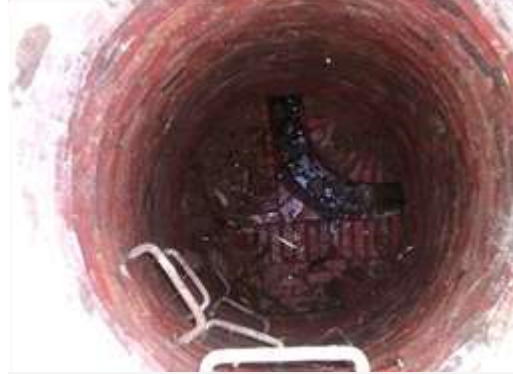
Top View

Evidence of surcharge - Bench debris.
Channel debris.

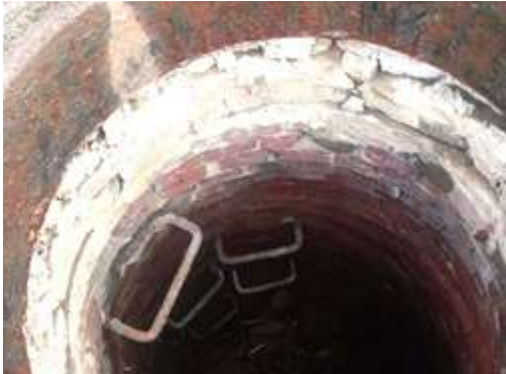
Defect

Frame leaks. Frame offset. Adjustment deterioration, loose brick and infiltration. Corbel and Barrel infiltration - other side.

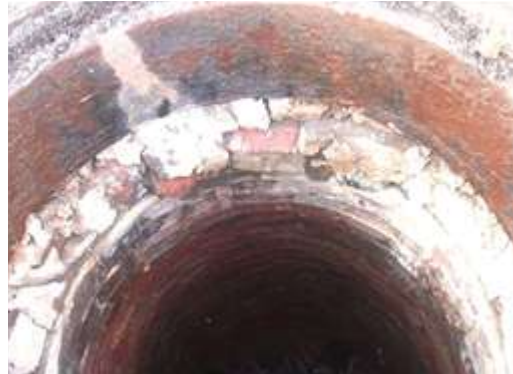
Defect

Frame leaks. Frame offset. Adjustment deterioration, loose brick and infiltration. Corbel and Barrel infiltration.

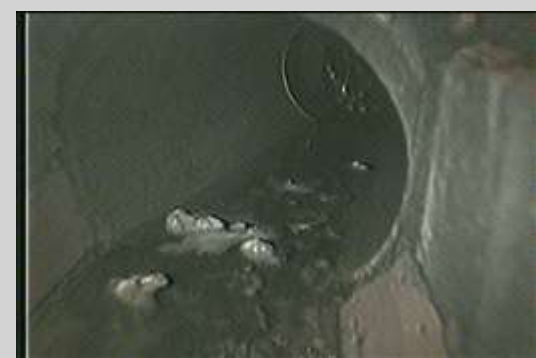
8 in. Circular Gravity Sewer Drop Out @ 12 O'Clock

Deposits: ☐ None ☒ **Mud** ☐ Sludge ☒ **Debris** ☐ Grease

Silt Depth: **0.5** (in.) Deposits Extent: **Light**

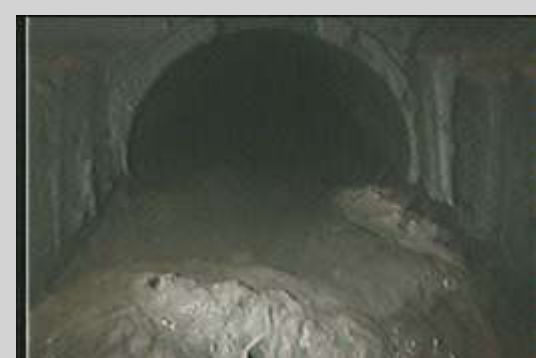
8 in. Circular Gravity Sewer Pipe In @ 3 O'Clock

Deposits: ☐ None ☐ Mud ☐ Sludge ☒ **Debris** ☐ Grease

Silt Depth: **1** (in.) Deposits Extent: **Light**

Infiltration: **Evidence** Pipe Seal Cond: **Cracked**
